HARBOUR HOME INSPECTIONS LIMITED

STANDARD VISUAL INSPECTION

INSPECTION: TP2907

INSPECTION LOCATION: 27 View Road, Takapuna

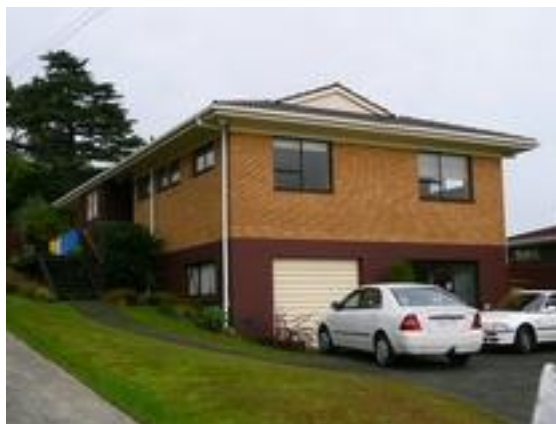
Northerly elevation

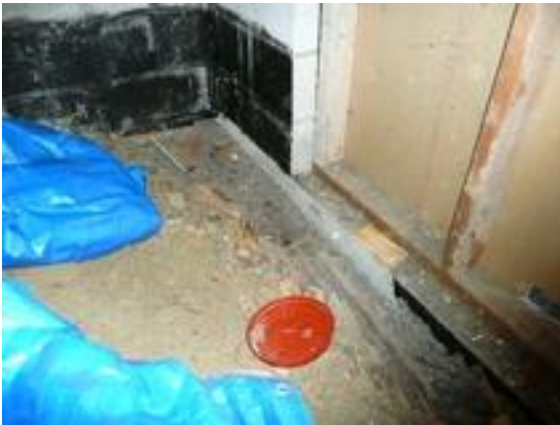
The dwelling is constructed on a standard concrete ring style perimeter footing bound by concrete base blocks which also support the brick cladding. Subterranean retaining walls are constructed between the south subfloor basement and north garage area. The retaining walls are waterproofed with a bitumen membrane and are backfilled in a professional manner. No internal water ingress is evident. The dwellings internal south timber subfloor area is supported with traditional timber jacks mounted on standard precast and braced concrete piles. The foundations are well constructed and are in a sound stable original condition. The mid-floor is standard timber joist and particleboard construction. The structural walls are framed with standard 100 x 50mm pine framing and include some additional structural members. The walls appear true. There are no signs of excessive movement.

Professional bitumen waterproofing

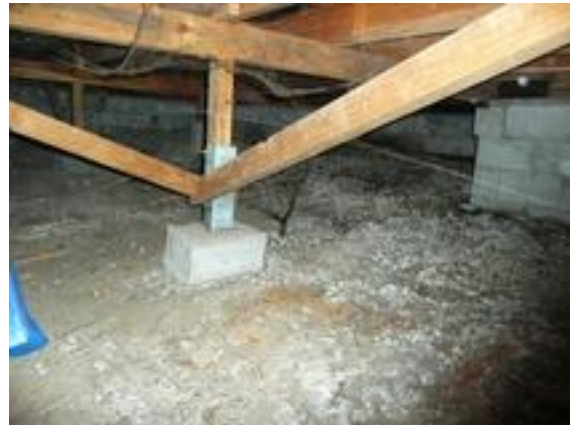
Brace pile & block perimeter footing

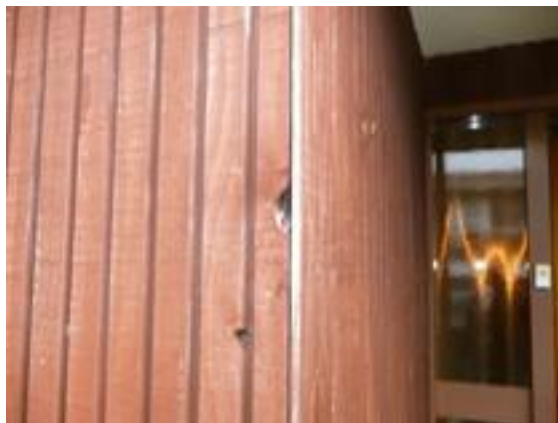
The dwellings main cladding is non-load bearing brick veneer. A ventilation cavity is constructed between the brick veneer and structural timber framing and weep holes are installed as required. The long life low maintenance bricks are in a good condition. The minor cladding is cedar vertical weatherboards. The weatherboards are in a reasonably good condition but some general maintenance would be beneficial. The small knot holes and the gap to the north corner should be filled and all the timber re-stained.

Fill holes, corner gap & re-stain

- Fill the knots in the east cedar cladding and the gap to the north corner and re-stain.

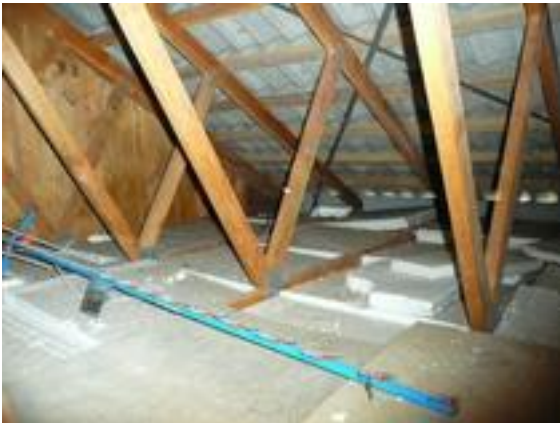
The truncated hip roof is constructed with standard prefabricated trusses. The trusses are clad with concrete tiles and are in a good original condition. The roof tiles have been recently painted and resealed and are in a good condition also. The lead flashings are well designed and installed.

Standard trusses

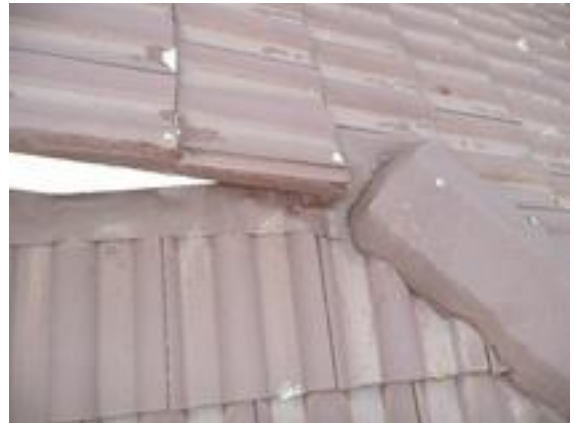
Well designed & installed lead flashings

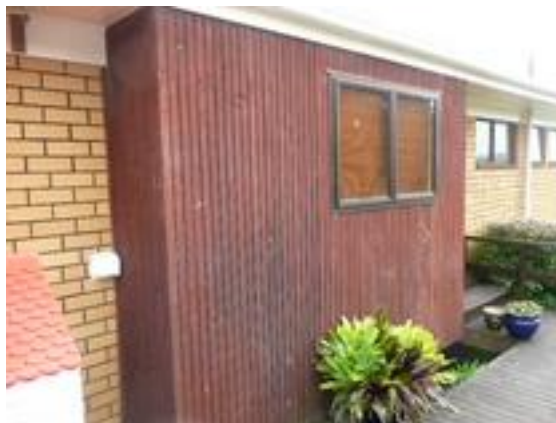
The entire perimeter of the dwelling has eaves except the pushed out kitchen area. Traditional square timber boards are used to form the fascia and bargeboards. Concrete fibre cement style sheeting is used to form the soffit. Both are in a good condition and have been recently repainted.

Recently painted fascia and eaves

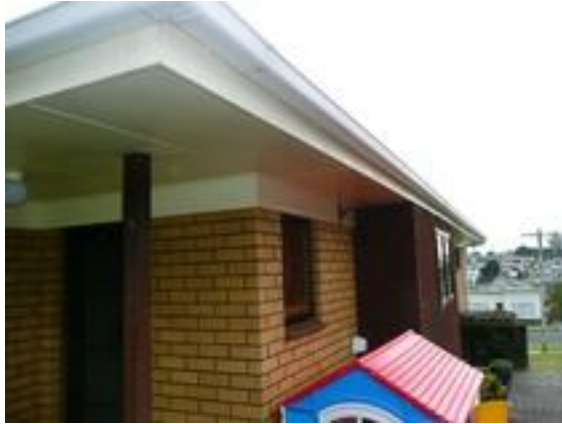
The spouting and round downpipes are standard PVC profiles. The spouting is new and has a reasonable fall. Both are in a good condition.

New PVC spouting

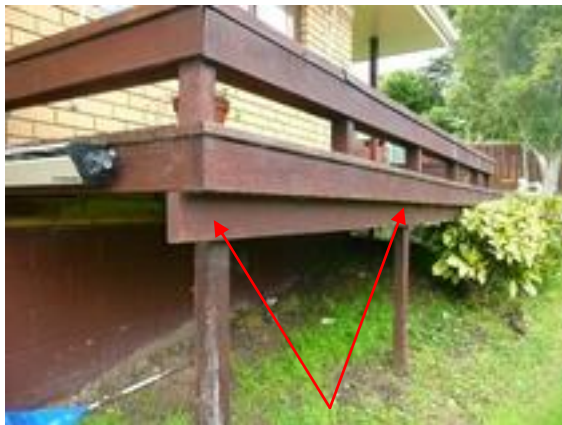
The south west deck constructed directly off the lounge is clad with pine decking. The deck is solidly constructed and includes some mechanical fixings, but no bolts are used to attach the two northwest posts to the bearer. The posts are secured to the bearers with nails but should be strengthened with a M12 galvanised bolt each post to bearer junction.

Intended location of new bolts (2)

- Strengthen the south west deck with one galvanized M12 bolt to both of the northern post / bearer junctions. (Approximately \$50)
- Lower the extractor to the original height or fit a longer cable that reaches the stove plug. (Approximately \$30)
- Replace the broken meter box plastic window. (Approximately \$40)

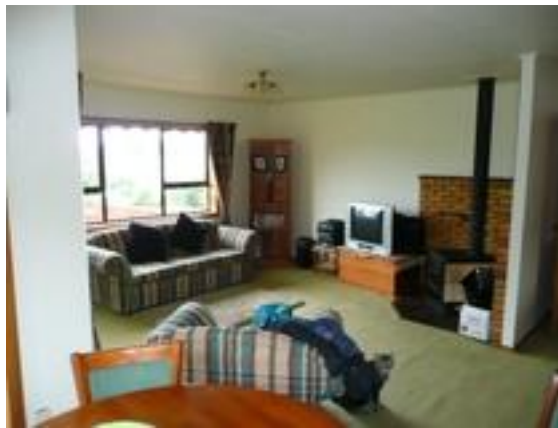
The lounge is open to the dining room and connects to the south west deck. A freestanding Kent firebox is installed. In a good condition.

Open lounge

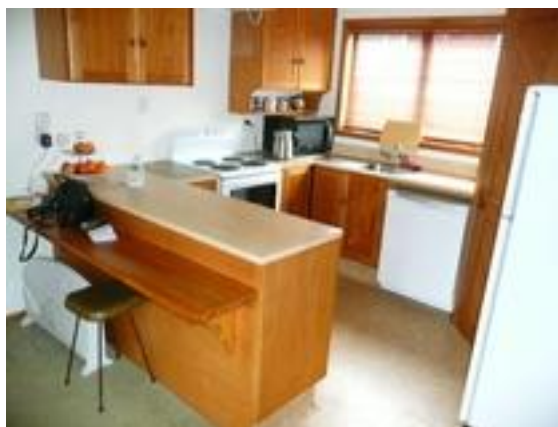
Standard kitchen with original timber style cabinetry. Includes an electric stove, rangehood, dishwasher and a pantry. Open to the dining room. In a good condition but the rangehood has been moved up the wall to a higher position where the cable will not reach the stove plug. A longer electrical cable should be fitted to the rangehood or the rangehood lowered back to its original position.

Kitchen with high mounted extractor fan

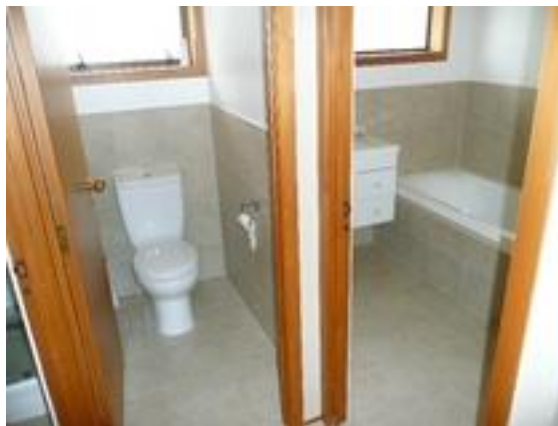
Three separately divided tiled bathroom areas including a bath area with a vanity and power point and separate private toilet and shower areas. All appear modern and are in a good condition.

Separate bathroom areas

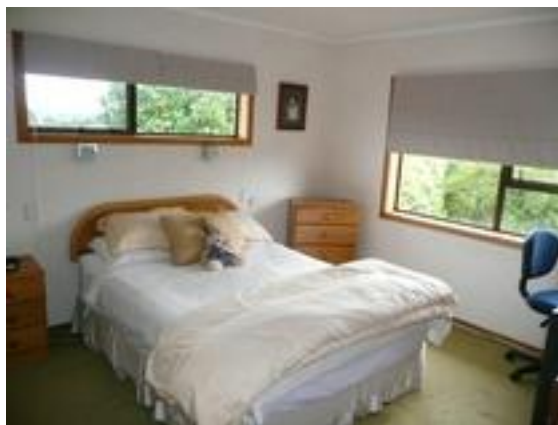
Two similar single bedrooms both with fitted single wardrobes and a large master bedroom with a double wardrobe. All are in a good condition and include blinds.

Master bedroom

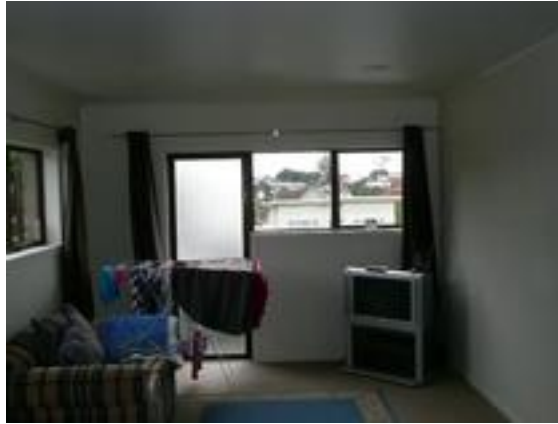
The large original basement rumpus room includes a study area, two cupboards and an external door. In a good condition.

Basement rumpus room

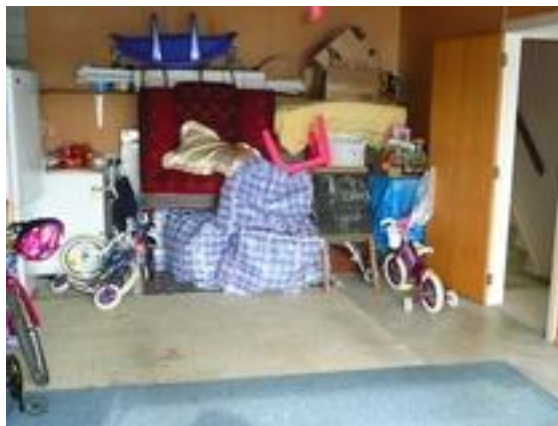
One car garage with electrically operated corrugated iron single tilt door. The garage is mainly exposed block cladding but is lined to the south end and includes a workshop and a large storage area. The garage also includes the main fuse board and is in a good condition.

Single garage

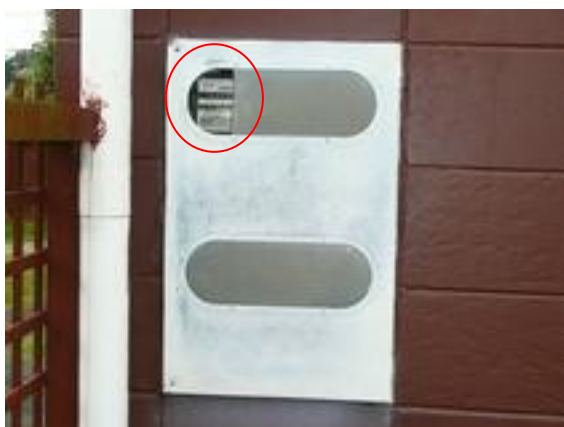
Underground power and telephone. The electrical meter board is located on the external rumpus room wall. The top plastic window for the meter board is broken and should be replaced. The main fuse board is located in the garage. The fuses used are standard miniature circuit breakers (x11) including an onboard earth leakage circuit which isolates the bathroom power point. All wiring viewed was the modern tough plastic sheath (TPS) variety. The kitchen extractor fan cable is too short to reach the stove plug.

Broken meter box window

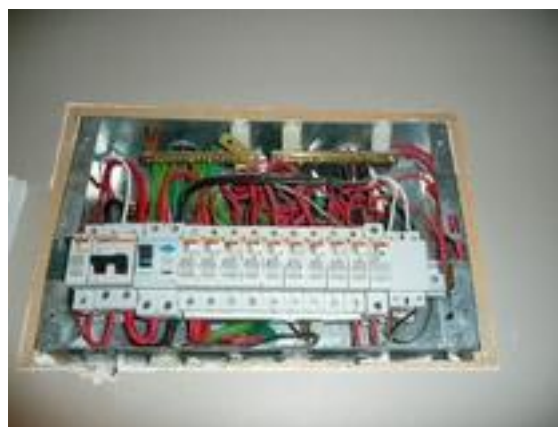
Standard miniature circuit breakers
